www.CountryHomeInspection.com

2120 N. Pacific Avenue #54
Santa Cruz CA 95060

Inspected By: Clive Belvoir ASHI 247382 FR 45419

Inspection Date: 8/25/2014

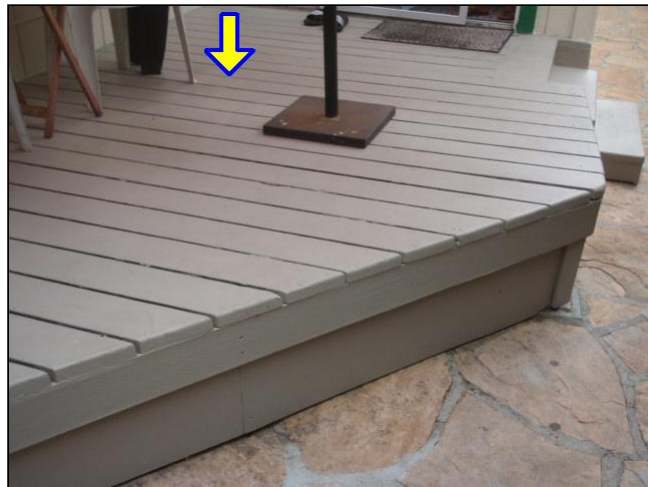
1.0 Item 1(Picture)

Low deck, clearance insufficient under deck. Noted on the left side deck. The underside of the wood deck(s) and framing were not inspected due to low clearance.

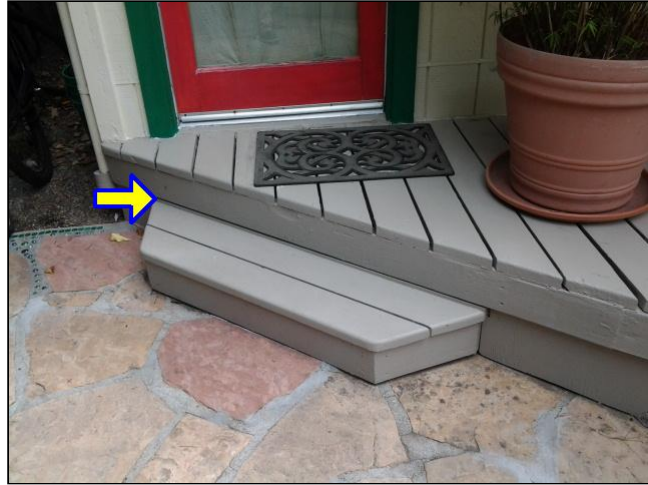
1.1 Item 1(Picture)

Exterior stairway height varies more than 3/8 of an inch. Noted on the rear stairs. Improper rise or run was noted at the stairs. This means that one or more of the stairs was higher or longer than the others or that the length of the stairs does not meet current standards. This should be considered a tripping hazard and correction is recommended.

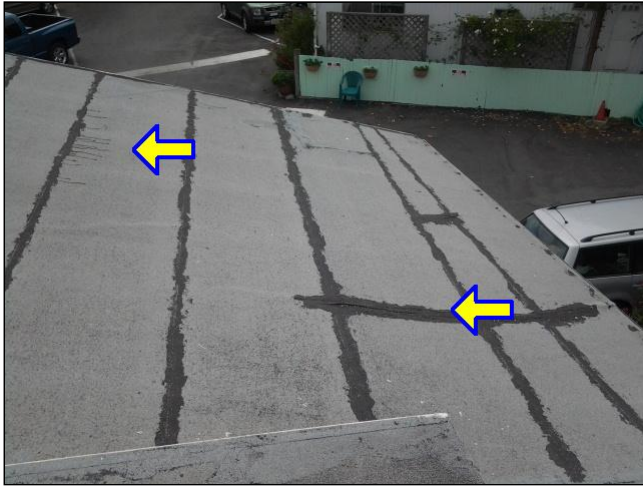
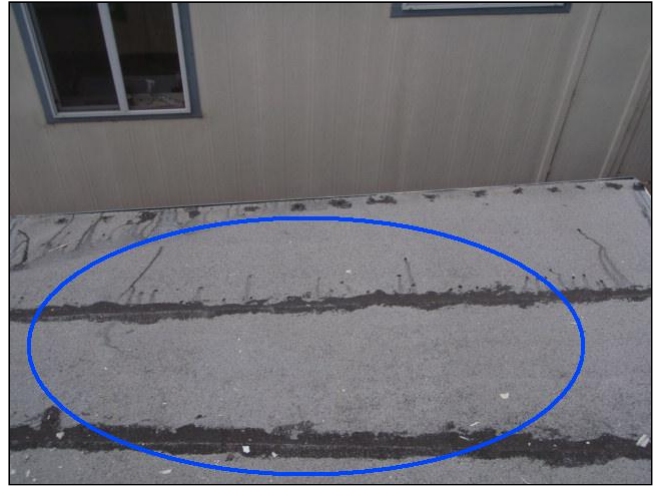
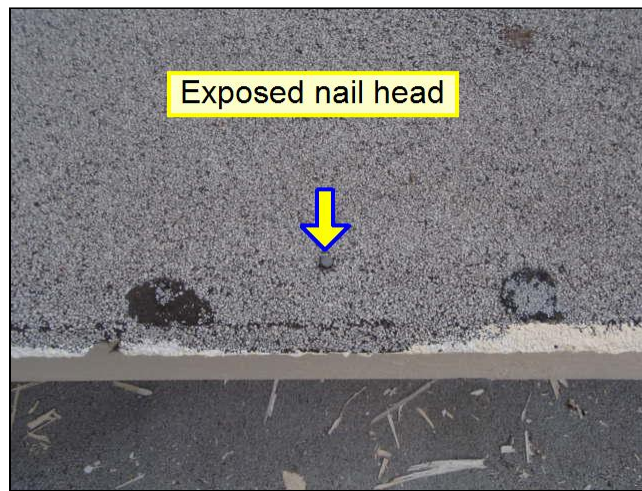
(1) Full evaluation and written findings with costs to cure by a qualified Roofing Contractor advised for all areas and components of the roof before the contingency release period. Sections of the roof material is lifting. Exposed nail heads are noted at various locations. Several areas of the roof have been patched.

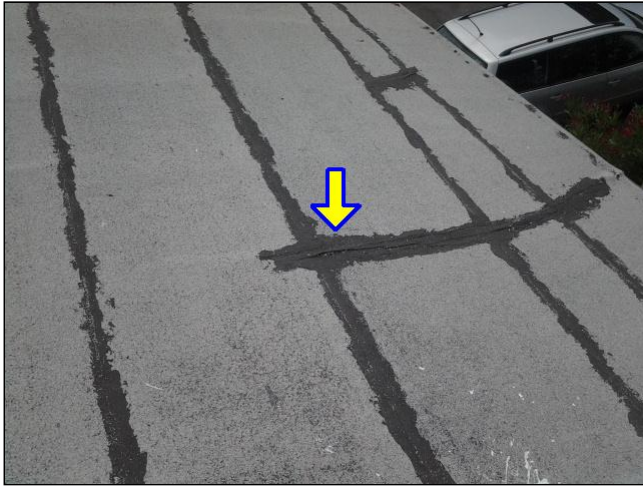
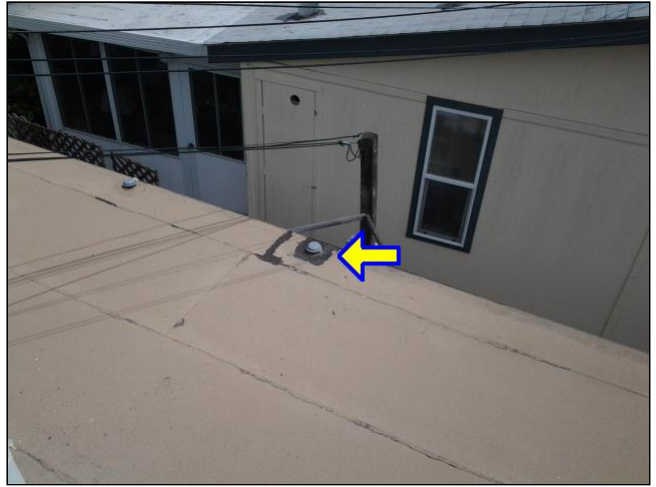
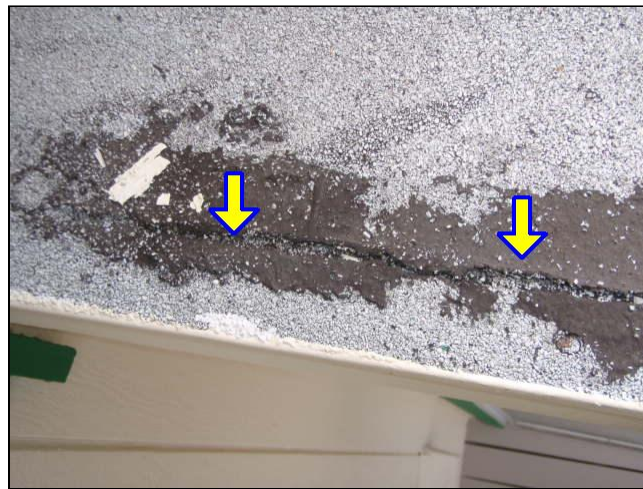
(2) Application of "tar" as temporary roof repair noted. Noted at the roof at various locations. Recommend installing the proper flashing or keeping the areas sealed as needed. Areas of the tar flashing is cracking or gapped. Recommend further evaluation by a qualified licensed contractor.

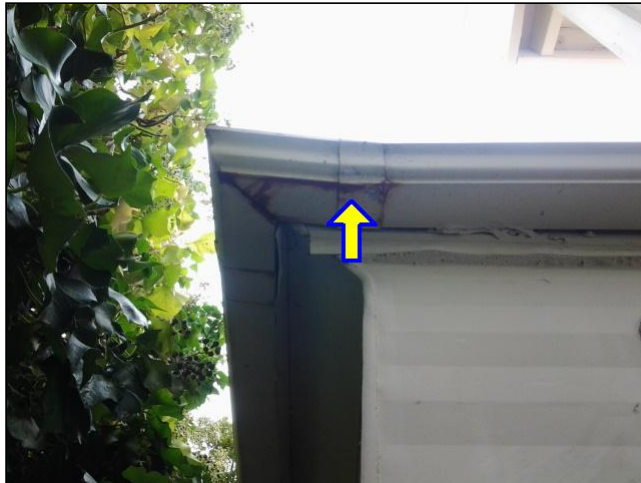
2.1 Item 1(Picture)

The gutter appears to leak at the seam on the exterior of the home at various locations. I recommend cleaning and apply gutter sealant or epoxy.

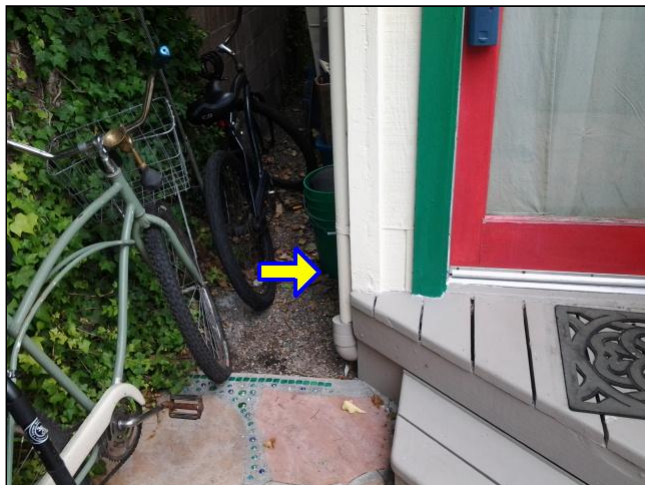
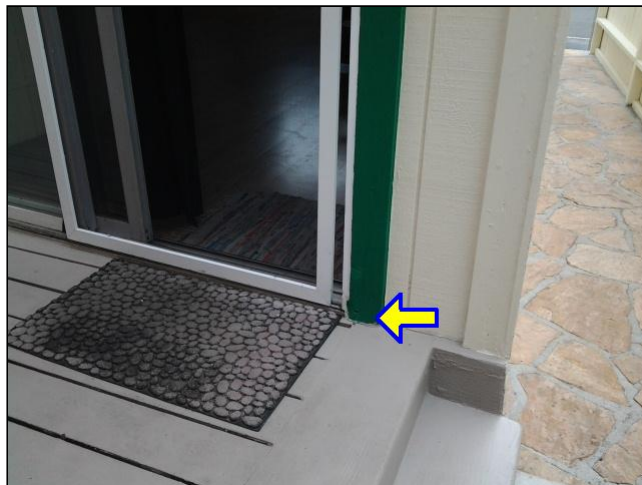
Trim damaged on the home at various locations. The trim has signs of dry-rot or fungus damage. Recommend refer to pest inspection for exact locations and further information concerning all areas of pest, dry-rot or fungus damage.

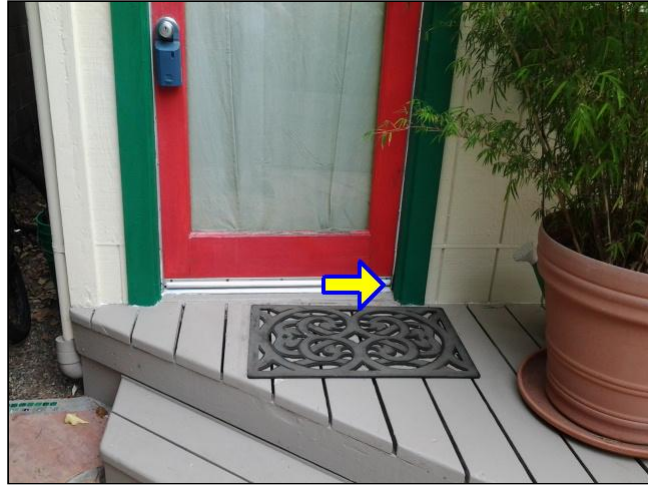
2.3 Item 1(Picture)

Door jamb damaged on the rear exterior door. Dry-rot or fungus damage was noted on the bottom of the jamb(s) at the door. Recommend refer to pest inspection for further information.

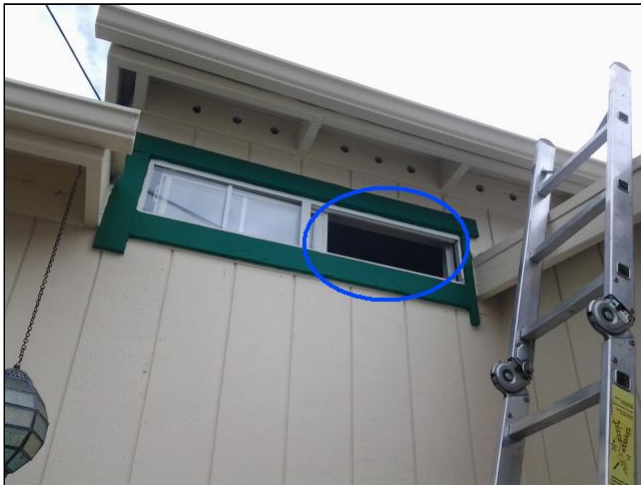
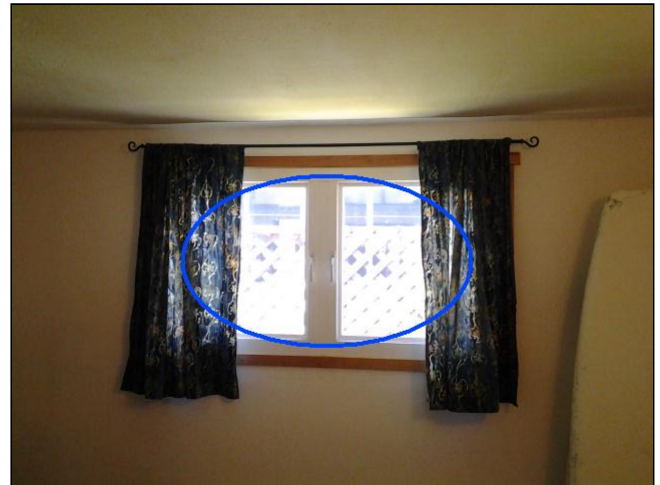
Window screen(s) are missing. Noted on a couple of windows in the home. Recommend the screens be repaired or replaced as needed.

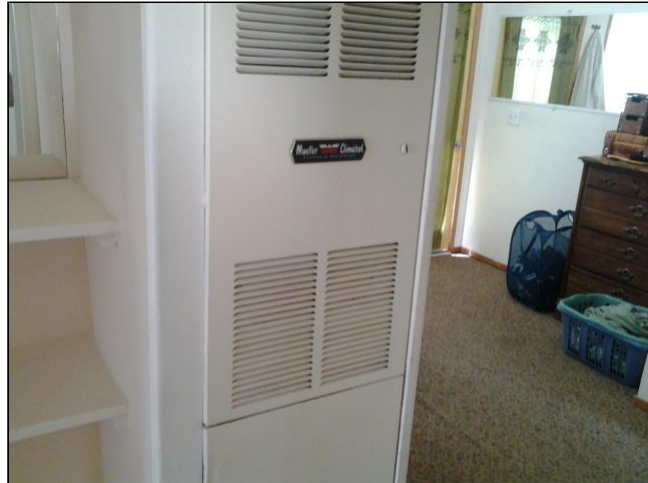
3.0 Item 1(Picture)

The furnace is an older unit. The typical life span of a furnace is 15 to 20 years. Many furnaces last well beyond this age. Because most components are not visible we recommend the furnace be further evaluated by a qualified HVAC contractor or have PG&E do a safety check. Anticipate the need for replacement.

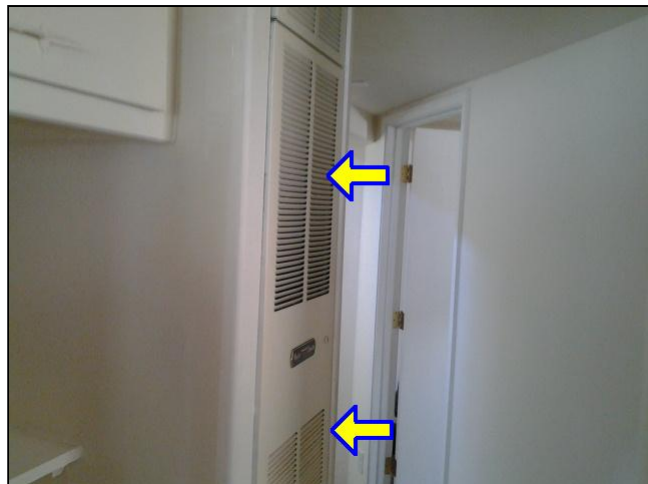
3.3 Item 1(Picture)

The furnace filter is missing. The filter needs to be installed. I recommend service or repair as needed.

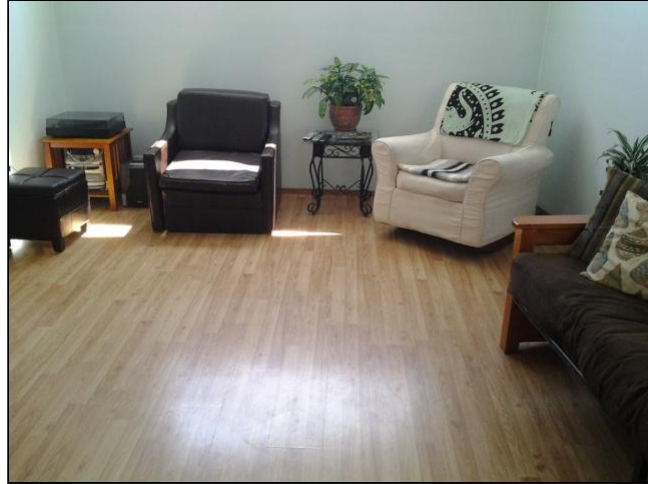
3.5 Item 1(Picture)

There is no heat source for the left side rooms. This is for your information.

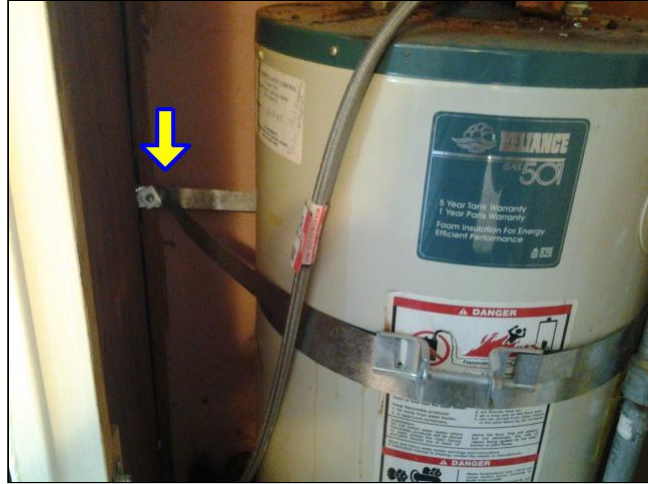
4.0 Item 1(Picture)

(1) Water heater seismic restraint system appears insufficient. Although the water heater is strapped with the correct straps, recommend the straps are installed on either side of the water heater to prevent movement. Before purchasing the property, further study and corrections, as needed, by a qualified licensed contractor are advised.

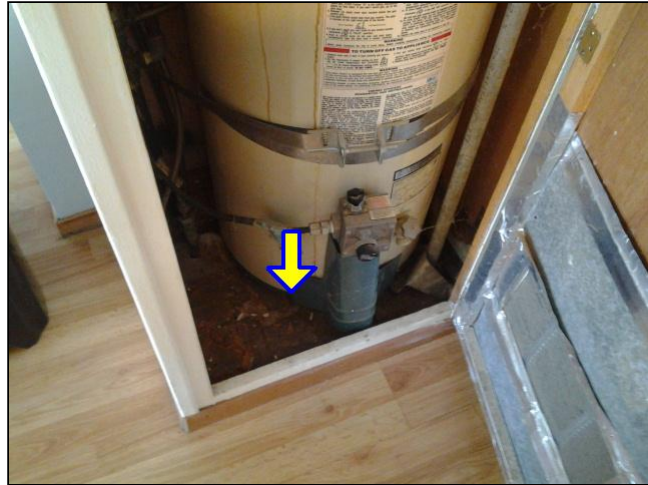
4.0 Item 2(Picture)

(2) Recommend installing a drain pan under the water heater with a drain to the exterior. This is recommended in case of a water leak at the water heater. The water will most likely drain to the exterior. Modification or addition is generally considered an upgrade which should improve safety or efficiency. The opinion of a qualified licensed contractor is recommended.

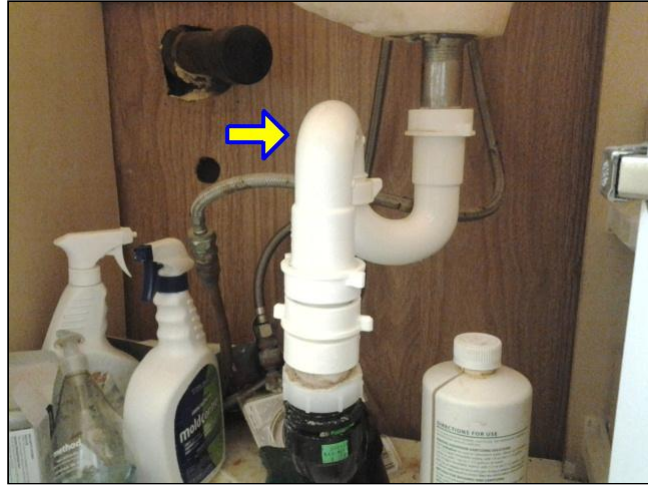
4.2 Item 1(Picture)

Drain trap improper. An S trap has been installed under the hall bathroom sink. This type of drain is improper and likely to siphon the trap during use and can allow sewer gases to enter the home. Further evaluation and repair as needed by a qualified licensed plumbing contractor is recommended.

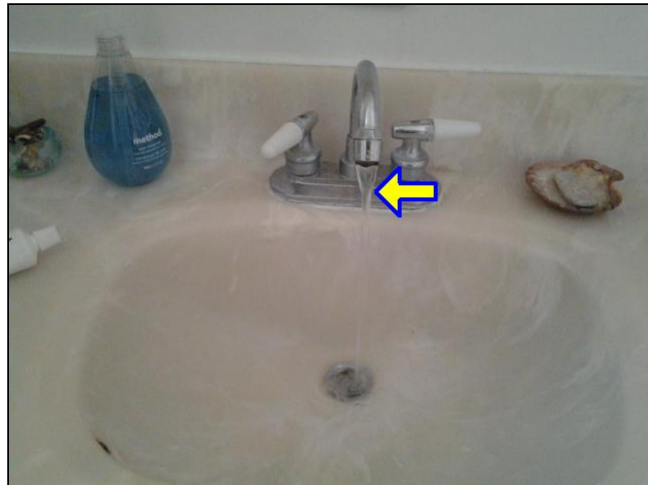
4.3 Item 1(Picture)

Water flow rate slows when two or more faucets are on. The flow reduction was significant at the time of the inspection. It is possible that the galvanized water lines are clogged inside the pipes and may need to be replaced to correct the flow. It is recommended that the finding be further evaluated by a qualified licensed plumber before purchasing the property.

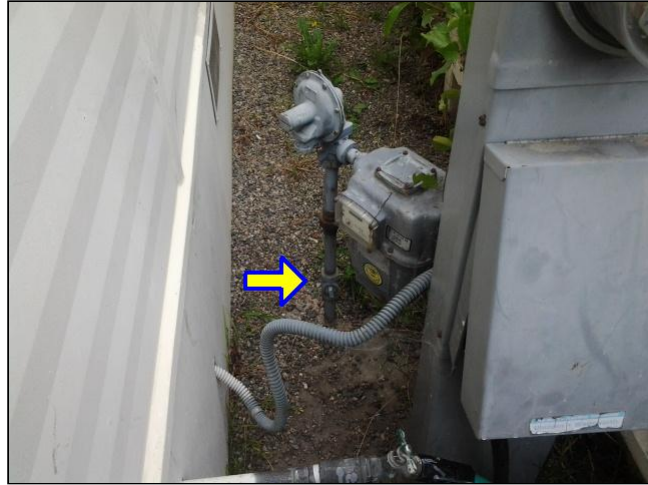
4.4 Item 1(Picture)

Recommend installing a wrench for the gas meter to turn off in case of an emergency. The wrench can be purchased at most hardware stores.

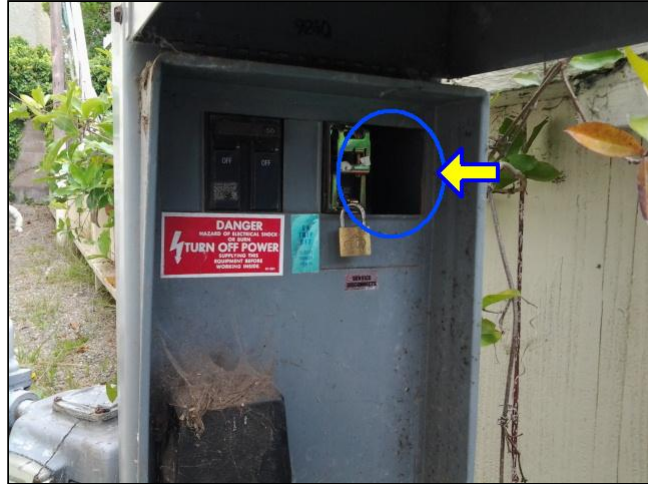
5.2 Item 1(Picture)

Breaker knockout missing from main-panel (exposes bus bar). Recommend installing knock-out covers at the panel. Knock-out covers are inexpensive plastic covers that cover exposed bus bars. Usually these are simply snapped into place. Knock-out covers prevent access to live power. The finding does not conform to building standards and practices in effect at the time of construction or installation. Before purchasing the property, further study and corrections, as needed, by a qualified licensed contractor are advised.

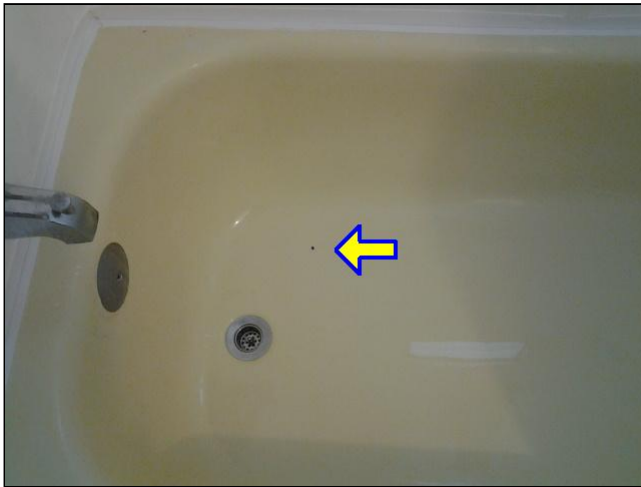
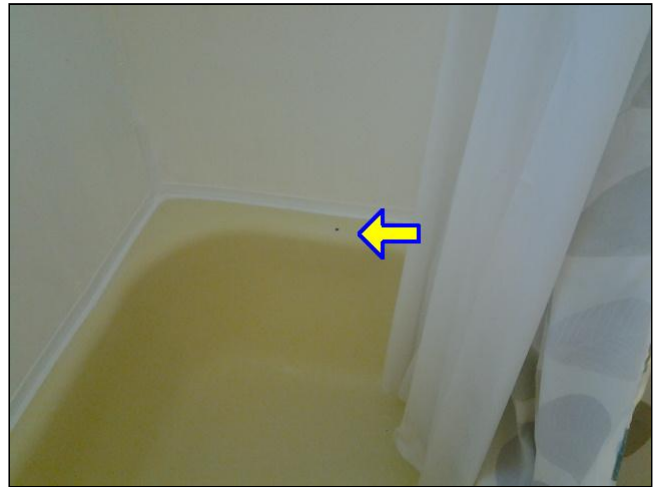
Porcelain or enamel chipped. A couple of small chips were noted on the bathtub. Maintenance, alteration or repair could be expected to improve component appearance and may decrease deterioration.

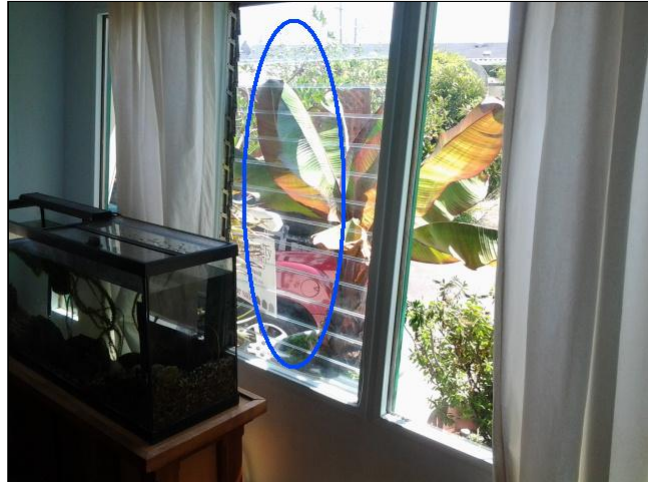
7.3 Item 1(Picture)

The jalousie window cranks are missing or are stuck shut. Recommend further evaluation and repair by a qualified licensed contractor if desired.

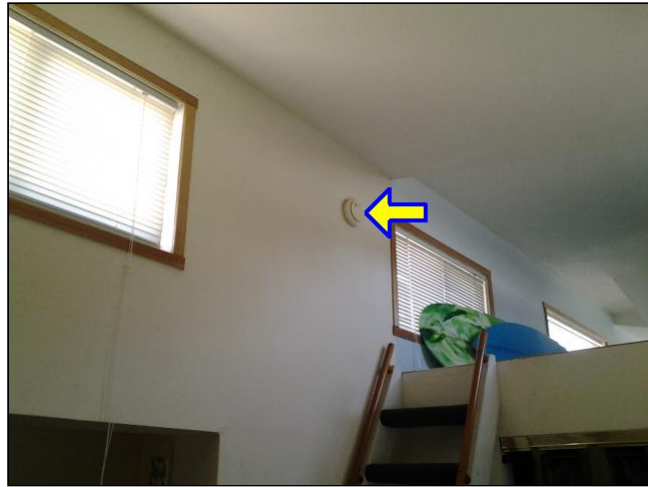
7.4 Item 1(Picture)

(1) Smoke alarm inoperative. Recommend replacing all non working smoke alarms and installing (PHOTOELECTRIC type smoke alarms) the smoke alarms outside the bedrooms and as a safety enhancement install smoke alarms in the bedrooms. We recommend periodic testing of smoke detectors to ensure batteries are charged. We also recommend changing batteries twice a year. The finding does not conform to building standards and practices in effect at the time of construction or installation. Before purchasing the property, further study and corrections, as needed, by a qualified repair person are advised.

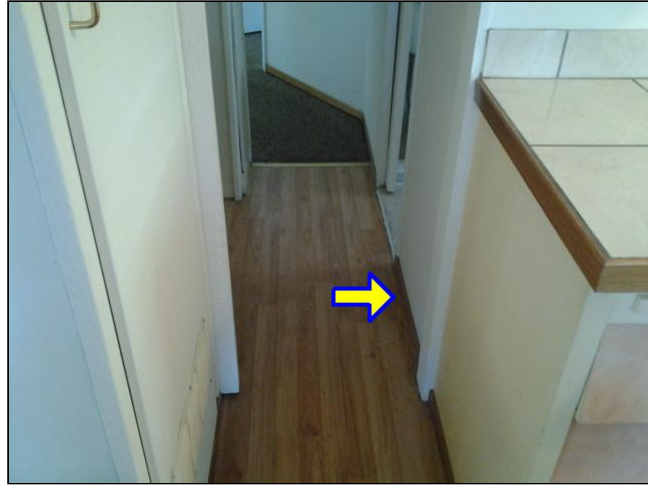
7.4 Item 2(Picture)

(2) There is no carbon monoxide (CO) detector(s) found in the home. C.O detectors are recommended outside bedrooms, in each sleeping area and on every level of the home including basements. We recommend the installation of C.O detectors in compliance with SB 183.

California Carbon Monoxide Poisoning ACT or 2010 SB 183 requires that all residential property be equipped with a carbon monoxide detector when the property has a "fossil fuel" burning heater or appliance, fireplace or an attached garage. The law provides that all single family homes including individual condos (owner or tenants occupied) must be equipped with a detector on or before July 1 2011. All other residential units (multi-family apartments and condominiums) must be equipped with a C.O detector on or before January 1, 2013. For more information www.fire.ca.gov/communications/downloads/factsheets/carbonmonoxide.pdf

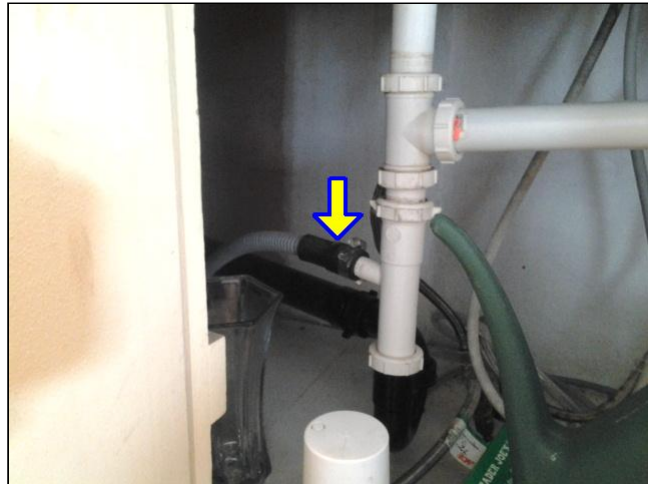
8.2 Item 1(Picture)

Dishwasher air gap not installed. The air gap serves as across-contamination prevention device. The dishwasher is connected to potable water and to the sewer system. There must be some device to prevent the two from mixing. The air-gap serves that purpose. Recommend an air gap be installed.

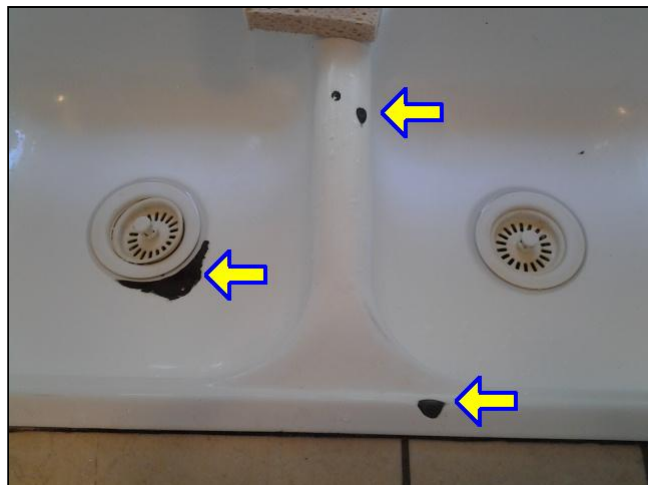
8.5 Item 1(Picture)

Sink enamel or porcelain chipped. Chips were noted on the kitchen sink. Maintenance, alteration or repair could be expected to improve component appearance and may decrease deterioration.

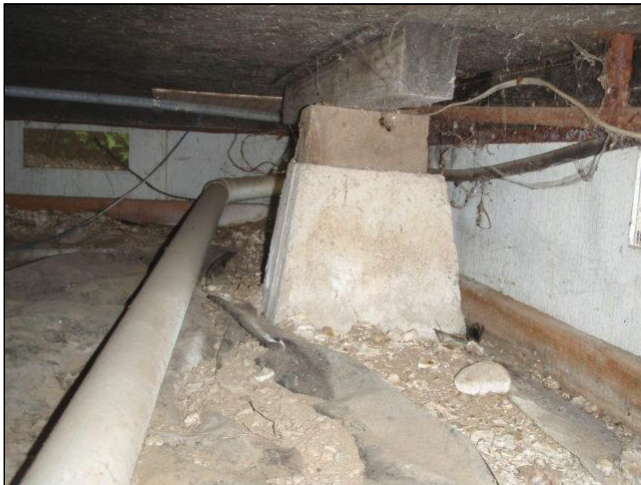
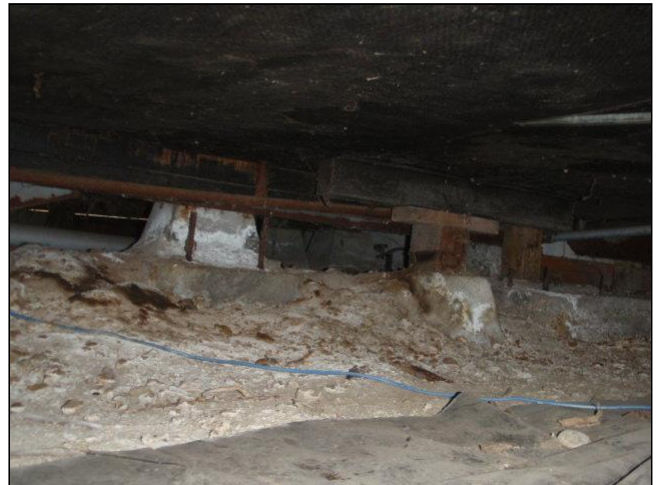
Earthquake bracing or anchors have NOT been installed in the sub-area under the mobile home. Modification or addition is generally considered an upgrade which should improve safety or efficiency. The opinion of a qualified licensed contractor is recommended.

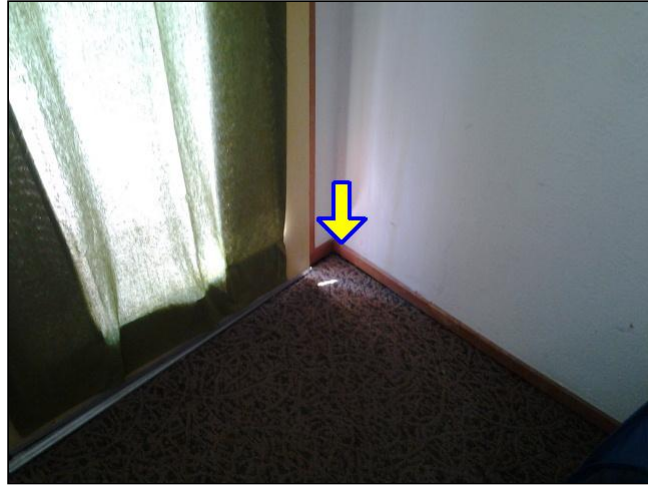
9.1 Item 1(Picture)

Wood deterioration noted in sub-flooring in the bedroom by the door to the exterior. Recommend refer to pest inspection or a licensed Contractor for further information concerning all possible areas with dry rot, pest or fungus damage.

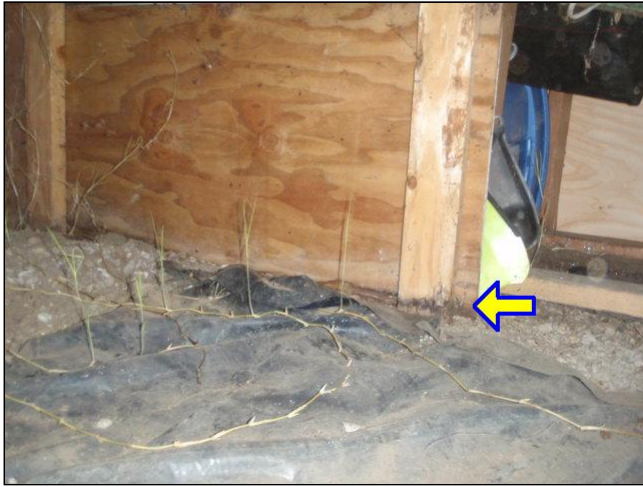
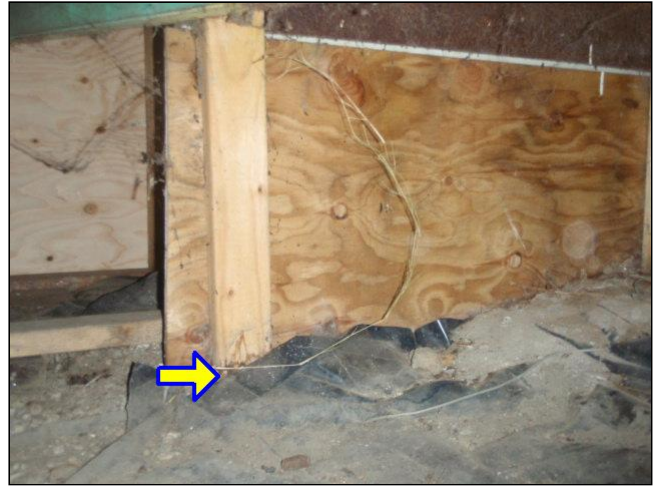
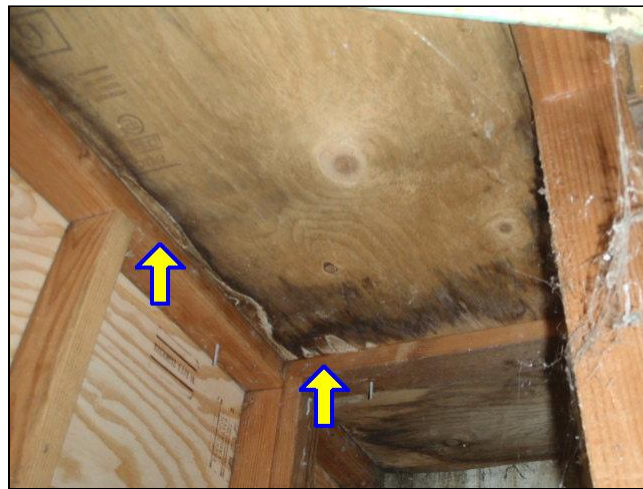
(1) Earth-to-wood contact noted under the front of the home. There is some fungus damage to the area. Recommend removing soil to break all earth to wood contact in the sub-area and refer to pest inspection for possible damage.

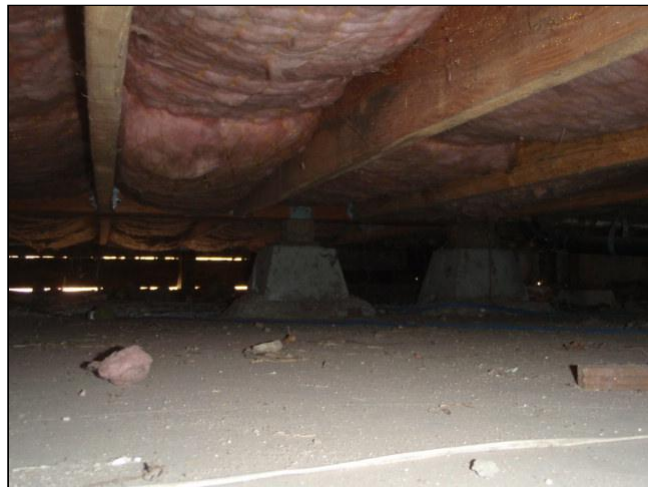
9.2 Item 4(Picture)

(2) Clearance under the left side of the home insufficient for access. The sub-area access is less than 18 inches of clearance between the soil and the floor joists making it inaccessible for physical inspection. Recommend further inspection after areas is made accessible.

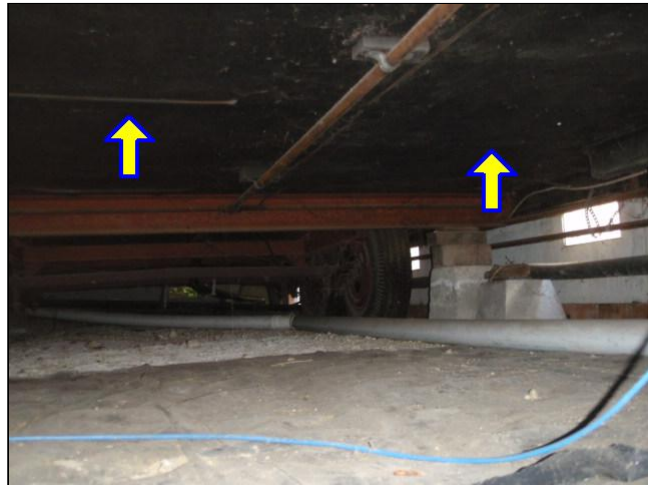
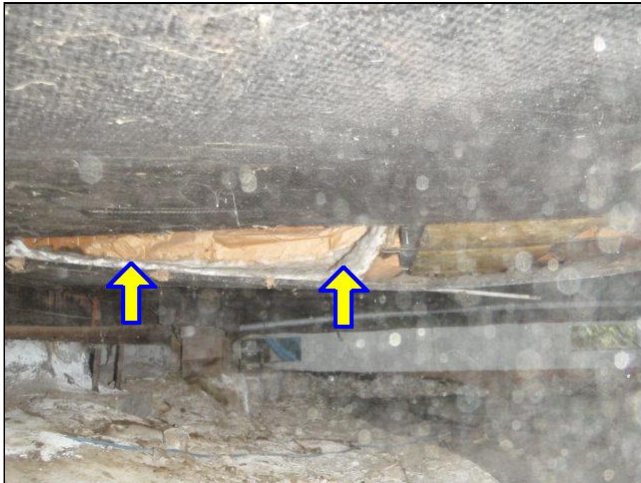
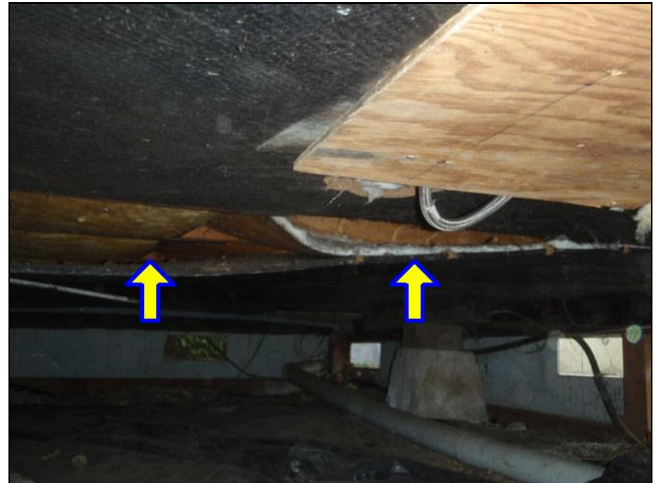
(1) Access impaired. The sub-floors were not fully viewed from the sub-area. Vapor barrier / belly board covers the sub-floor which prevents viewing. The vapor barrier also covers areas of the heating ducting, electrical wiring and water lines.

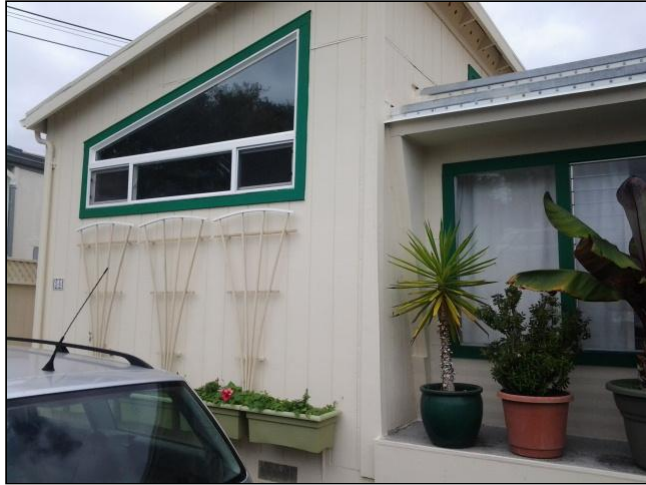
9.5 Item 1(Picture)

(2) Remodel, alterations, or additions noted. Areas of the home have been added on. Be sure to check for permits. The inspector cannot ascertain whether or not permits were used.
